CASE REPORT

The Paradox of a Radiculous Maxillary Second Premolar: A Case Report

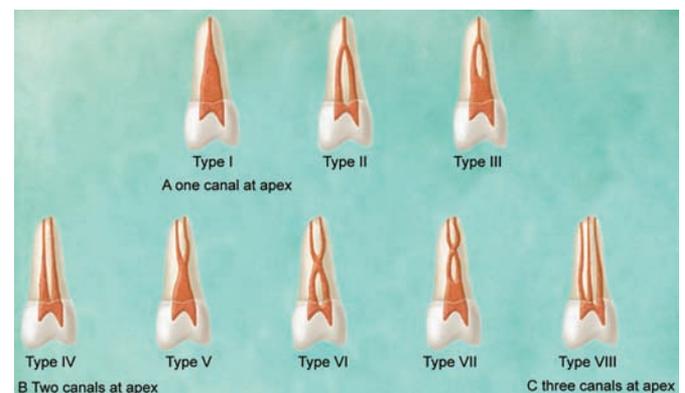
Fig. 1: Diagrammatic representation of Vertucci's canal configurations.⁴

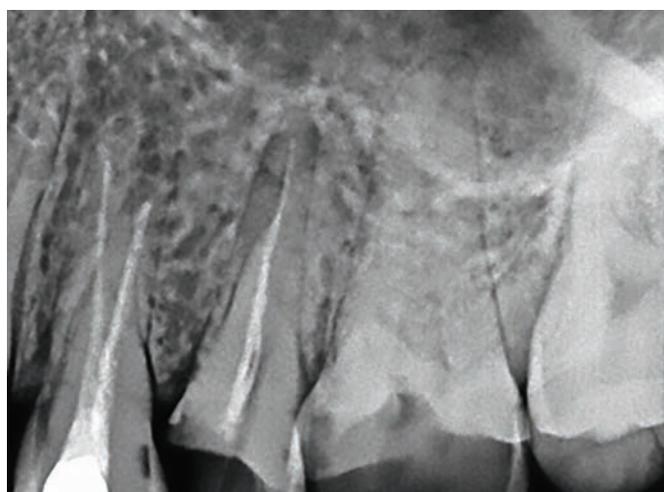
Fig. 2: Preoperative intraoral periapical radiograph of 25 showing unsatisfactory obturation and widening of PDL space

odontic therapy with maxillary left second premolar 2 years ago. Clinical examination revealed no extra or intraoral soft tissue abnormalities; the probing depth was within normal limits, and the affected tooth was tender to vertical percussion. The tooth showed proximal caries mesially. There was no coronal restoration present. Pre-operative radiographs revealed unsatisfactory obturation and presence of an extra root outline distally suggestive of an extra root widening of the periodontal ligament was evident with the palatal root (Fig. 2). A diagnosis of previously treated tooth with symptomatic apical periodontitis was made. Medical history was non contributory. Thus, the treatment plan decided was non surgical endodontic retreatment. Patient consent was obtained and treatment was initiated.

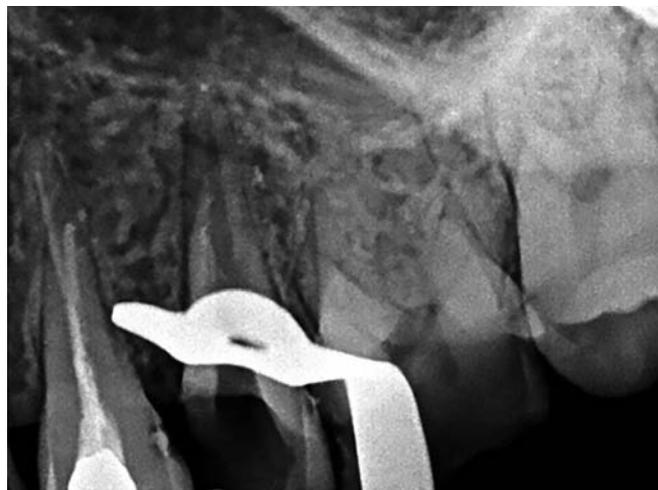
Fig. 3: Radiograph of 25 showing complete removal of previous root canal filling material

The retreatment procedure was initiated under rubber dam isolation in the left maxillary second premolar. The access cavity was re-entered using a number 2 round carbide bur. Gutta percha was detected in the palatal canal only. Coronal flaring was done using gates glidden drill number #1 and #2 (Mani Inc, Japan). Previous root canal filling (RCF) material was removed completely using Hedstrom file (#15–40, Mani Inc, Japan) along with xylene (Fischer scientific, Thermo Electron LLS India Pvt Ltd) in a crown-down technique. The removal of RCF material was verified radiographically (Fig. 3).

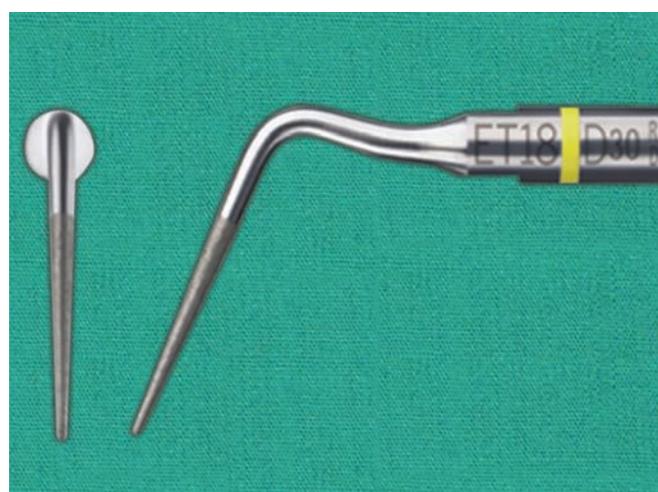
Fig. 4: ET18D US tip

On clinical examination of access cavity, it was seen that the buccal orifice was eccentric in location. Access cavity was visualized under DOM (OPMI Pico, Carl Zeiss Pvt Ltd, Germany) at 1.6 X magnification and access refinement was made distally using ET18D Ultrasonic tip (US tip), (EndoSuccess Retreatment Kit; Acteon, Merignac, France) at power setting of 3 (Fig. 4). The access cavity was triangular in outline (Fig. 5). The buccal canal was seen bifurcating 5 mm below the level of pulpal floor into mesiobuccal and distobuccal canal (Fig. 6). The canals

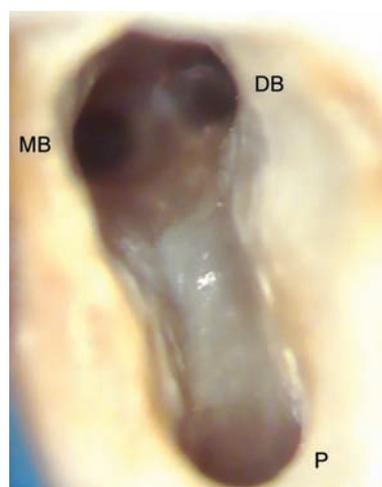
Fig. 5: T" shape access cavity preparation of 25 visualized under dental operating microscope (DOM) at 1.6X magnification showing three canal orifices—mesiobuccal (MB), distobuccal (DB) and palatal (P)

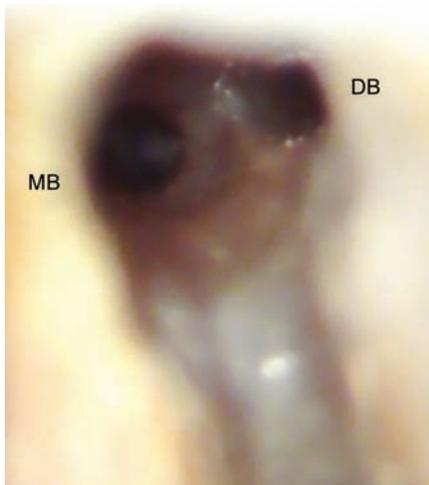
Fig. 6: DOM image of 25 showing the deep bifurcation of the main buccal canal into mesio Buccal (MB) and disto Buccal (DB) canals viewed at 1.6X magnification

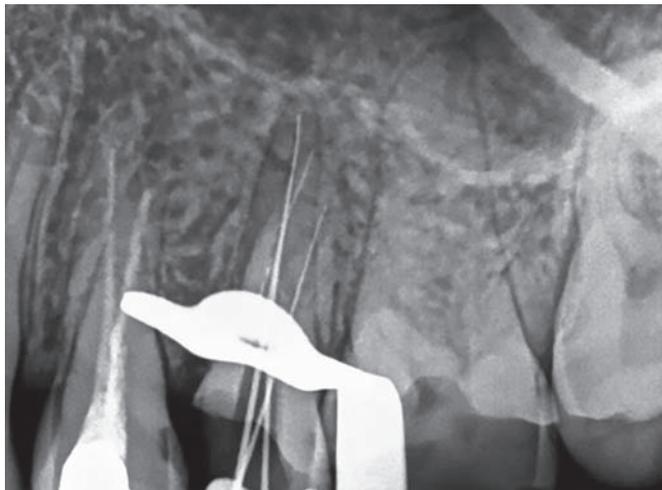
Fig. 7: Working length radiograph of 25

were scouted with #10 k file (Mani Inc, Japan). Tentative working length was determined using electronic apex locator [Raypex5, Verein Deutscher Werkzeugmaschinenfabriken (VDW), Munich, Germany] and verified radio-

graphically (Fig. 7). Cleaning and shaping was completed using profile rotary files (Dentsply, Maillefer, Ballaigues, Switzerland) to an apical size preparation of 25/0.06 with both buccal canals and 30/0.06 with palatal canal. The canals were intermittently irrigated with 2.5% sodium hypochlorite (NaOCl); (Trifarma Pvt Ltd, Bhiwandi, Thane). A total volume of 25 mL of 2.5% NaOCl was used for irrigation during cleaning and shaping procedure. An intracanal medicament of sterile calcium hydroxide (CH) powder (Prodent, Ratnagiri) mixed to a thick consistency with 2% Chlorhexidine (CHX); (SafePlus, Neelkanth Pvt Ltd, Jodhpur) was placed into the canals for one week. Cotton pellet was placed in the pulp chamber and the access cavity was temporized with zinc oxide eugenol cement (Deepak Enterprise, Mulund, Mumbai).

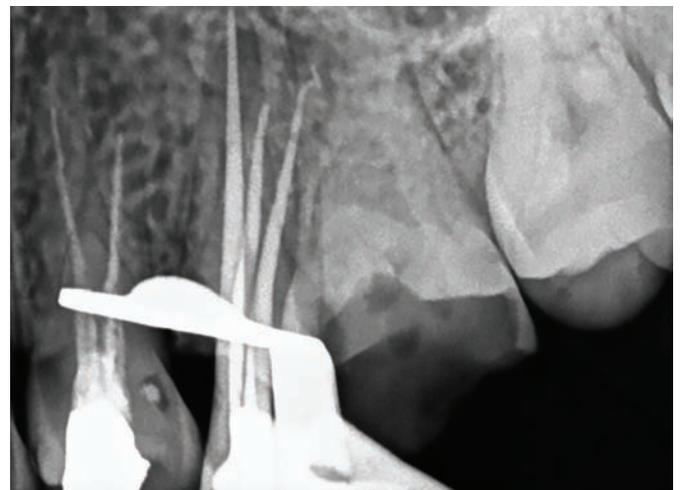
Fig. 8: Master cone selection radiograph of 25

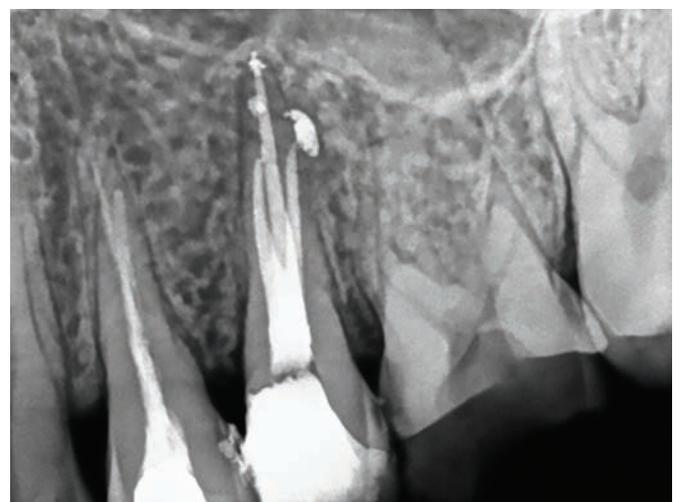
Fig. 9: Obturation radiograph of 25 showing adequate filling of all three canals along with filling of lateral canal in palatal root. Sealer extrusion noted with distobuccal canal

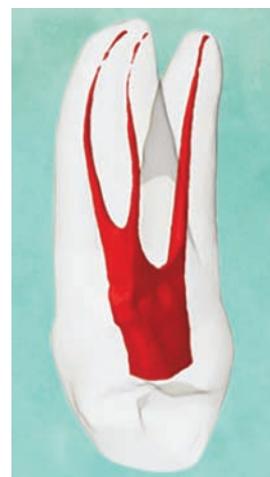
Fig. 11: Diagrammatic representation of maxillary second premolar with three canals classified according to Ahmed et al as 25 B¹⁻²P¹ where in B¹⁻² denotes buccal root with one orifice dividing into two canals having two separate portals of exits and P¹ denotes single palatal canal having one portal of exit¹³

Bellizzi has classified root morphology of maxillary second premolars into the following three groups namely: (1) three fused roots or fused buccal roots and a partially fused or separated palatal root; (2) buccal roots fused at the middle or apical third, and with a separated or partially fused palatal root; and (3) all three roots separated at the cervical third.⁵ In the present case report, the root canal system could be classified as Type III as per Gulabivala classification wherein first canal orifice divides into two different canals and second canal orifice exists as a single canal; thus two canal orifices exit as three different portals (Fig. 10).¹² According to the new classification given by Ahmed et al. in 2016, the radiculous premolar can be classified as 25 B¹⁻²P¹ where in B¹⁻² denotes buccal

root with one orifice dividing into two canals having two separate portals of exits and P¹ denotes single palatal canal having one portal of exit (Fig. 11).¹³

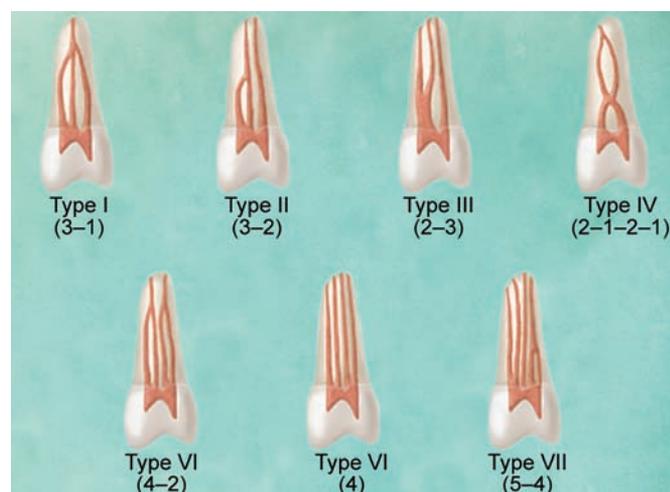
Fig. 10: Diagrammatic representation of Gulabivala and co-workers' supplemental canal configurations.¹²
