The Effects of Various In-Office Reconditioning Methods on Shear Bond Strength, Morphology of Slots and Bases of Stainless Brackets: An *in vitro* Study

¹Nidhi Bansal, ²Ashima Valiathan, ³Kshitij Bansal

How to cite this article: Bansal N, Valiathan A, Bansal K. The Effects of Various In-Office Reconditioning Methods on Shear Bond Strength, Morphology of Slots and Bases of Stainless Brackets: An *in vitro* Study. J Ind Orthod Soc 2011;45(4):175-182.

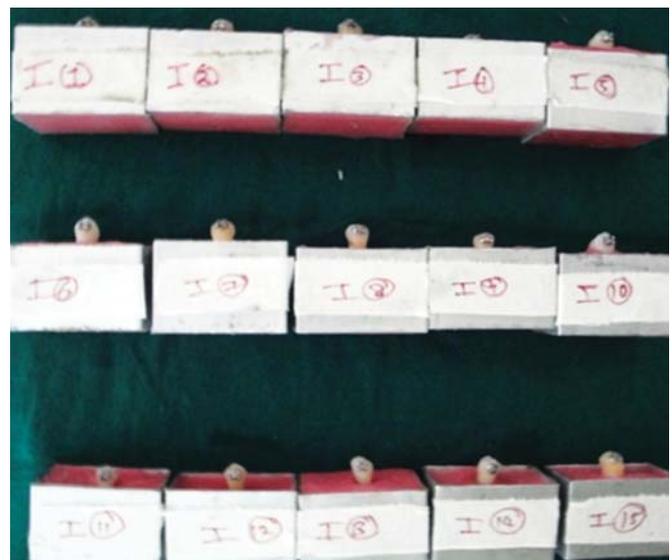
Fig. 1: Group I: New and unconditioned brackets bonded for the first time

Control and experimental brackets were bonded to the same teeth (Figs 1 and 2) as described.^{19,20} For rebonding, the residual composite resin on all the teeth was removed from the enamel using carbide finishing bur in a high-speed dental handpiece.

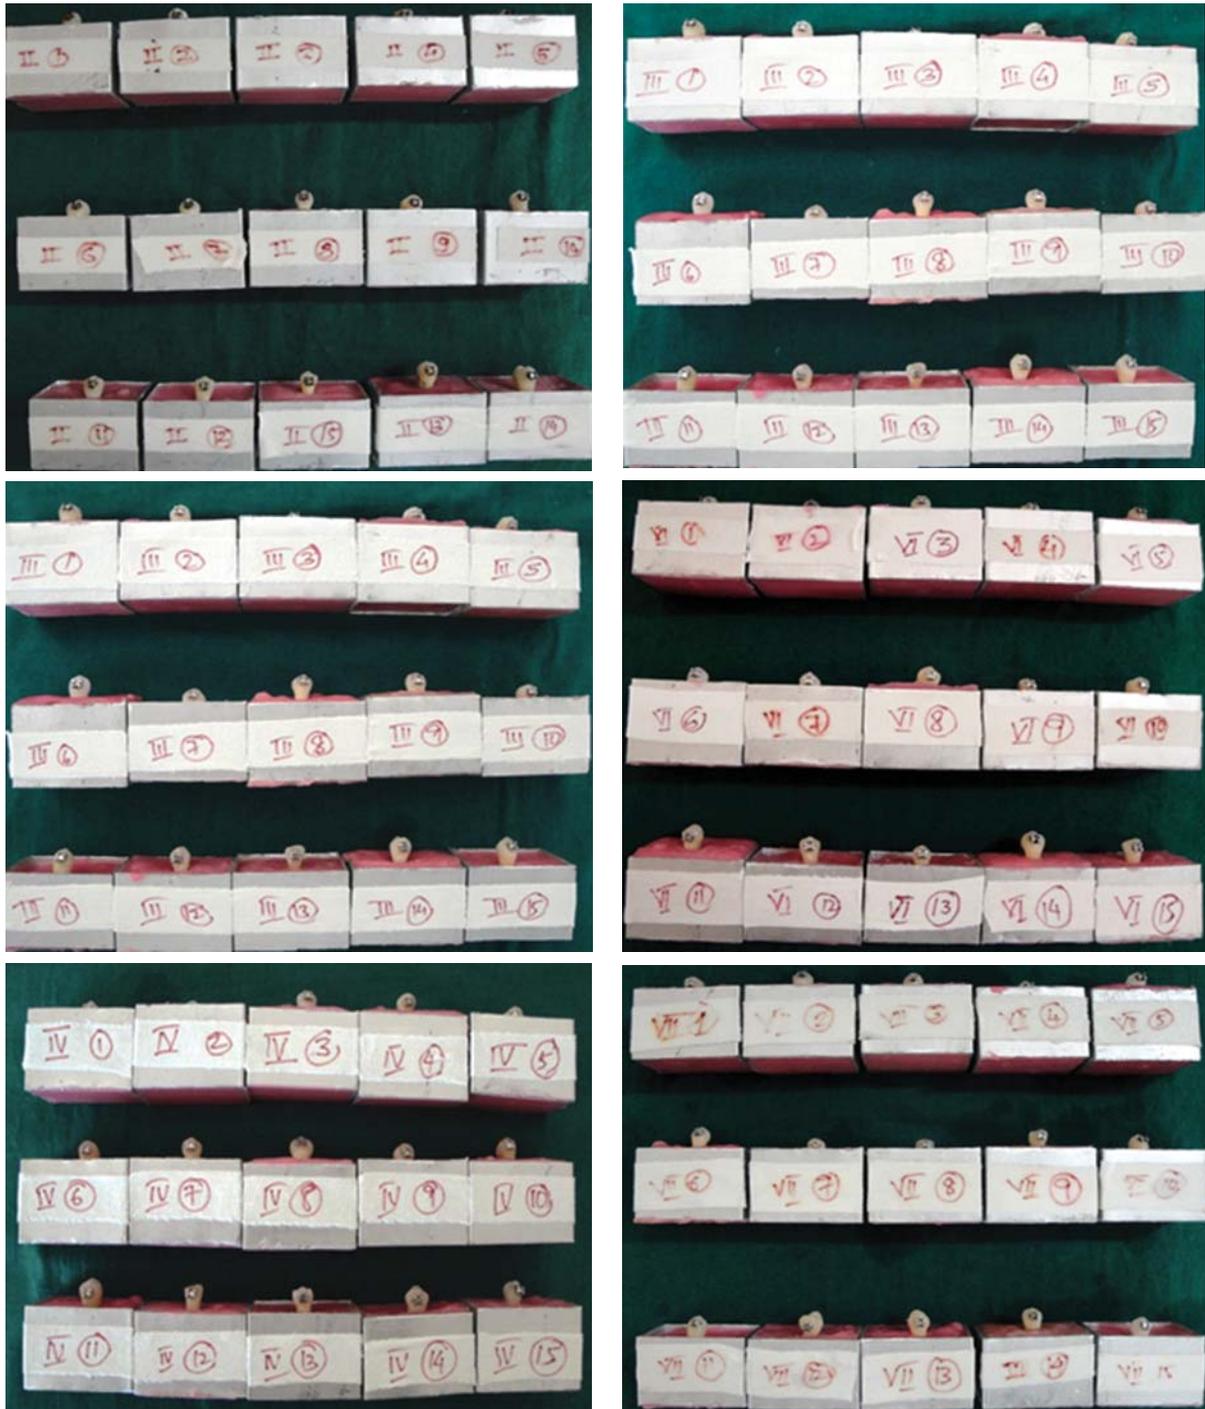
Fig. 2: Groups II to VII: Reconditioned brackets were rebonded on the same teeth

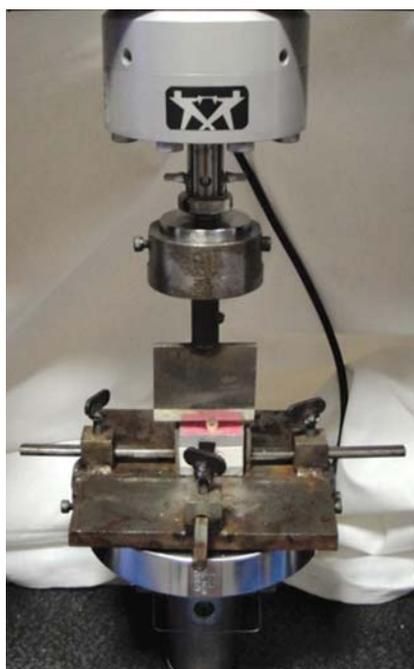
Fig. 3: Bond strength was tested using Instron Universal Testing Machine (Instron model 3366)

After 24 hours, both control and experimental groups were tested for bond strength using universal testing machine. An occlusogingival load at 0.5 mm/minute crosshead speed was applied at the bracket adhesive interface (Fig. 3) and shear/peel stress was recorded in megapascals (MPa).

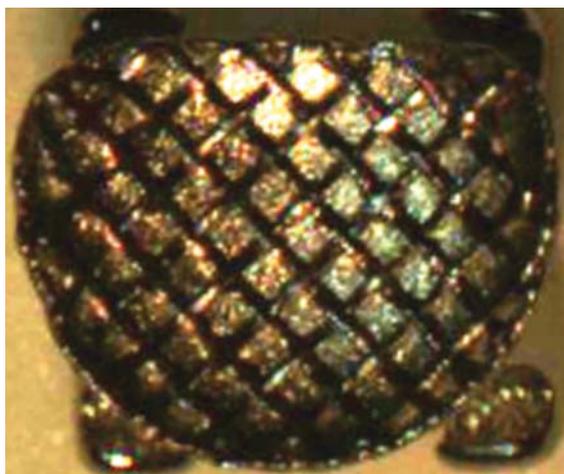
Fig. 4: Group I: Bracket base appearance with intact multi-stranded structure and clean retentive areas

Examination of the bases with stereomicroscope revealed that the control brackets had a smooth base with a multistranded wire structure and clean retentive areas in between the wire strands (Fig. 4). Group II brackets had most of their retentive areas filled with the adhesives (Fig. 5). In Group IV in majority of samples, the wire mesh were disrupted. The retentive areas are larger in size than that of controls indicating loss of metal during electropolishing (Fig. 6). In Group V, bracket base had clean retentive areas and intact wire mesh (Fig. 7). In Group VI, bases were filled with adhesive and had marked disruption of multistranded framework (Fig. 8). None of the Buchman group brackets had any adhesive remnants when viewed. The bases were intact and had clean retentive areas (Figs 9 to 12).

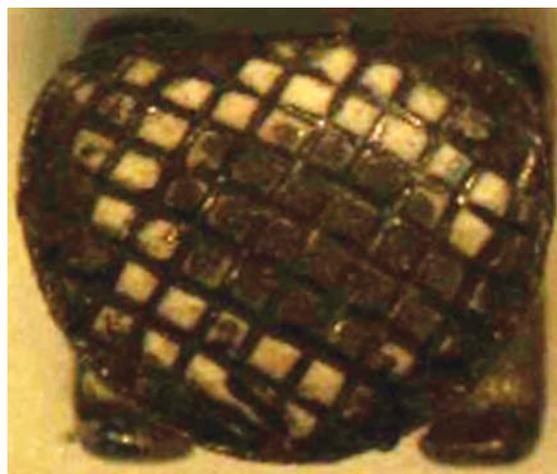
Fig. 5: Group II: Bracket base appearance after flaming showing adhesive filled undercuts and slight discontinuity in the strands' network

Lower bond strengths were seen in groups where reconditioning was done by flaming. It was probably because of the incomplete removal of the adhesive (indicating that flaming for 5 seconds was insufficient to combust all the composite), as most of the brackets in Group II, VI, when viewed in stereomicroscopy, had their retentive areas filled with adhesive resin. Electropolishing may affect brackets with an undercut base by opening up the retentive undercuts and smoothing the base, leading to a decrease in retention.

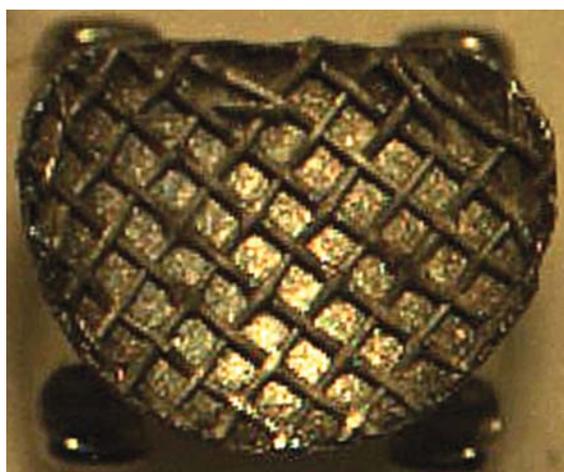
Fig. 6: Group IV: Bracket base appearance after reconditioning appeared very similar to controls with clean retentive areas; however, in majority of samples, the wiremesh were disrupted. The retentive areas are larger in size than that of controls indicating loss of metal during electropolishing

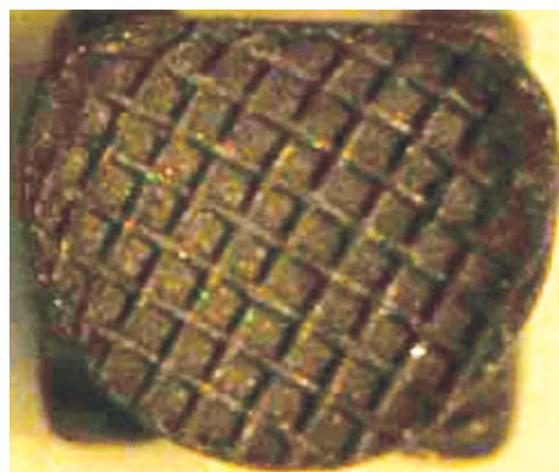
Fig. 7: Group V: Bracket base appearance after reconditioning appeared very similar to controls with clean retentive areas and intact wiremesh

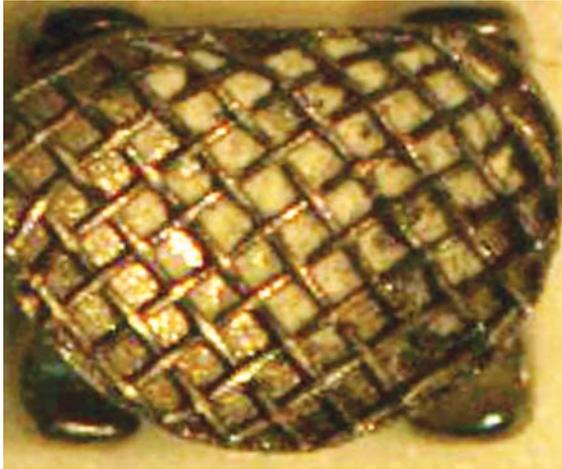
Fig. 8: Group VI: Some of brackets were similar to the controls, while others were filled with adhesive and all had marked disruption of multistranded framework

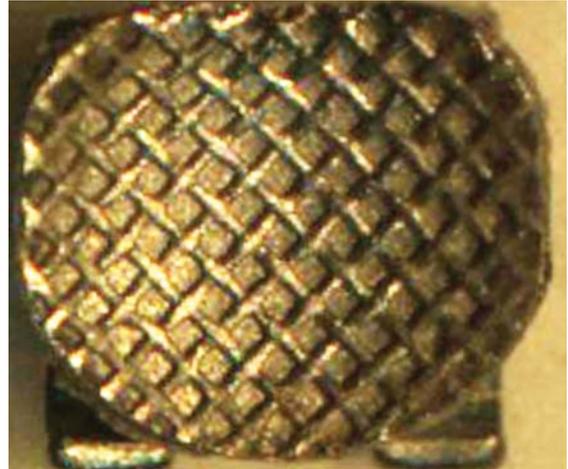
Fig. 9: Group VII: None of the Buchman group brackets had any adhesive remnants when viewed. The bases were intact and had clean retentive areas

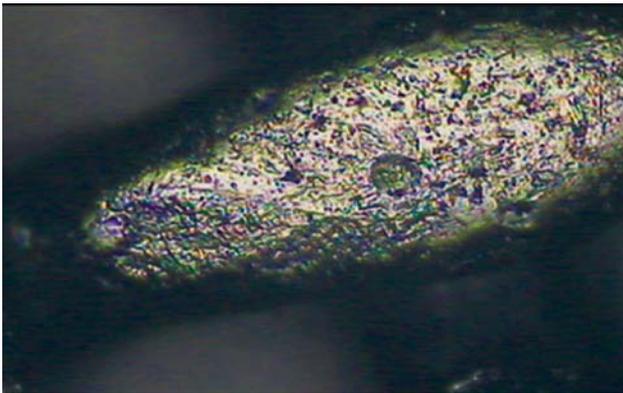
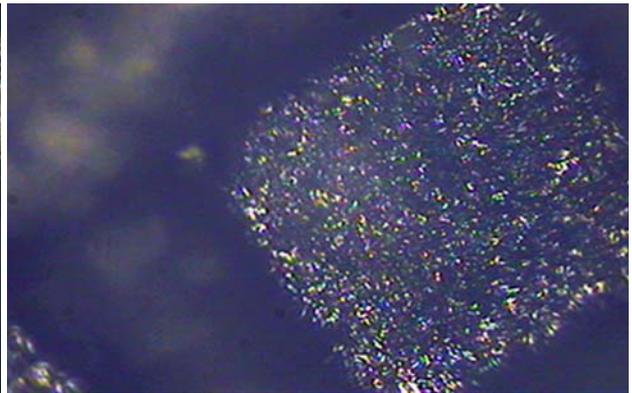
Fig. 10: Group I: Bracket base appearance of control samples before recycling shows smooth wiremesh and retentive areas. Note the lack of roughness

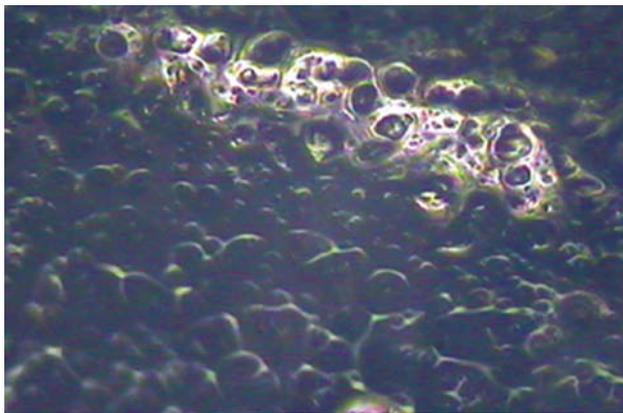
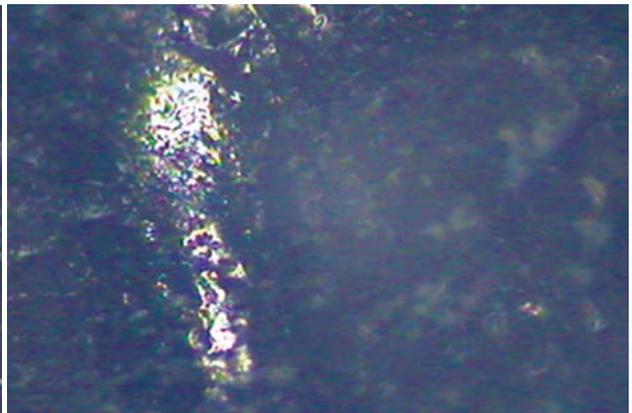
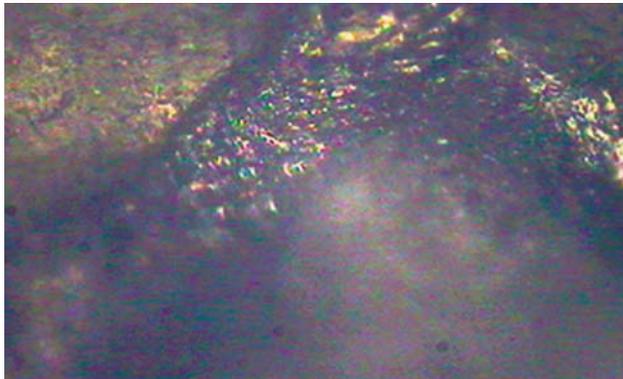
Fig. 11: Group III: Bracket base appearance after sandblasting shows roughened mesh similar to an etch pattern thereby increasing the surface area

The sandblasted brackets showed roughened meshwire framework that probably increased the rebond strength and gave values comparable to the control samples. The time taken to sandblast the flamed mesh is shorter than other methods.

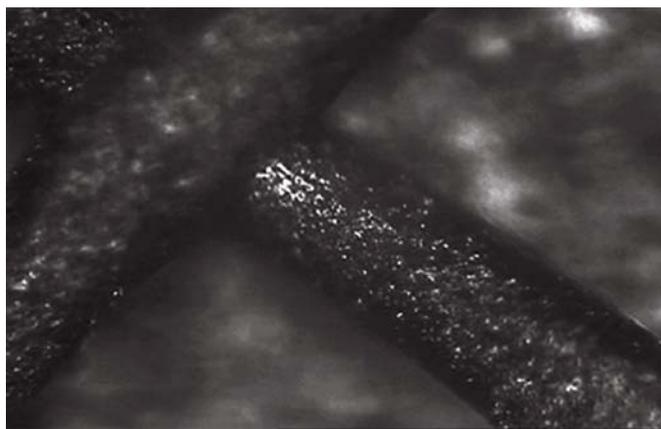
Fig. 12: Group IV: Mesh strand appears thinner and smoother than control samples
