CASE REPORT

Esthetic Management of Misplaced Implant

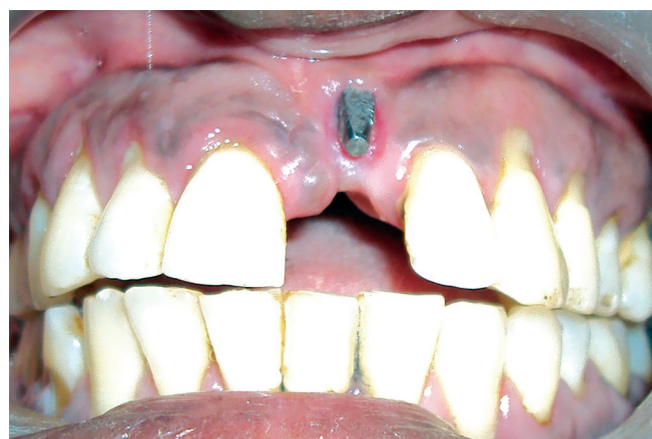
A 42-year-old female referral from the oral surgery was reported to the Department of Prosthodontics, Government Dental College and Hospital, Nagpur, with implant placed in maxillary left central incisor region. Intraoral clinical examination revealed far buccally placed implant in maxillary left central incisor region (Fig. 1). The patient was concerned mainly for esthetics. Recontouring of the soft tissue was essential to achieve natural emergence profile, so according to treatment plan gingivectomy surrounding the implant was done. Open tray impression technique was used to make the final impression. Impression was made and the cast was obtained. Working cast was marked 1 mm wide around the implant site and scraped to a depth of 2 mm for fabrication of provisional restoration (Figs 2A to C). Cast scraping and fabrication of provisional restoration was

Fig. 1: Labially misplaced implant

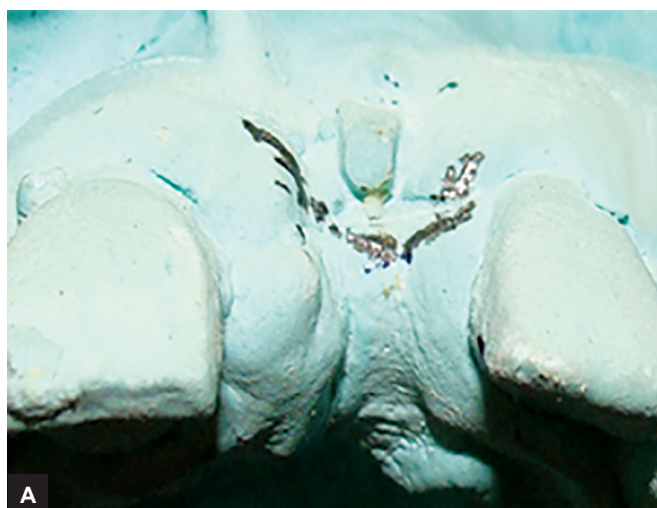
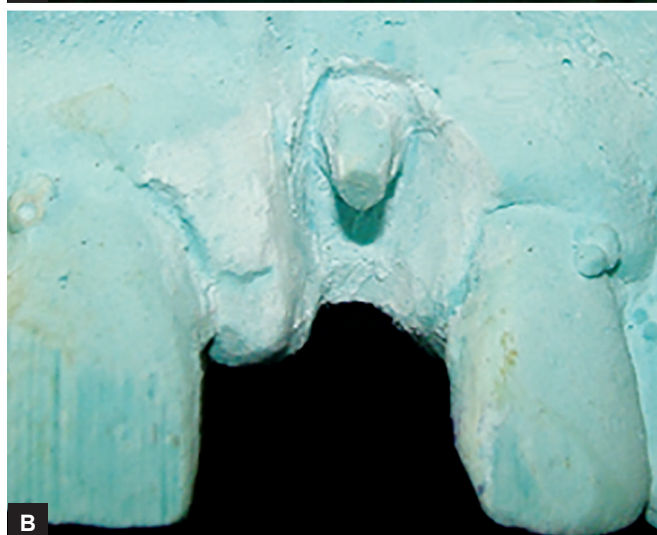
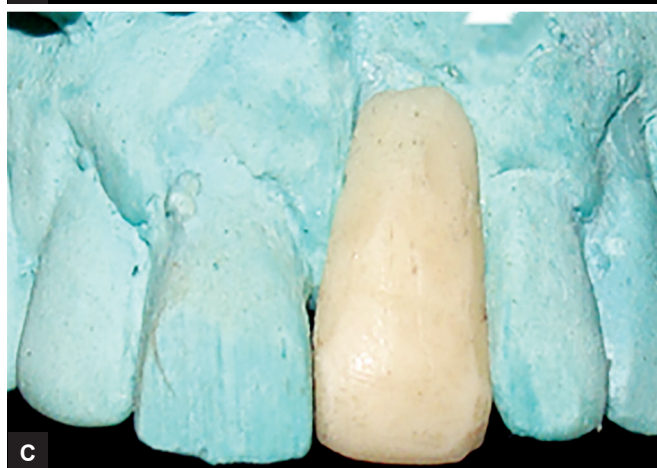
Figs 2A to C: (A) Labially misplaced implant, (B) cast scraping procedure, and (C) provisional restoration

repeated at a regular interval to create emergence profile surrounding the implant. The patient was recalled after 1, 3, and 6 months regularly to check the position of gingiva. After creating the emergence profile, final impression was made and metal coping was fabricated (Figs 3A and B). Shade selection was done and gingival porcelain was added to give esthetics to final restoration (Fig. 4).

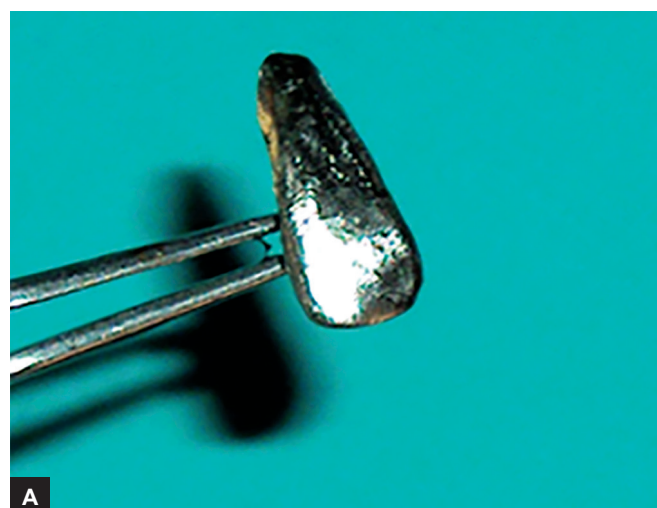
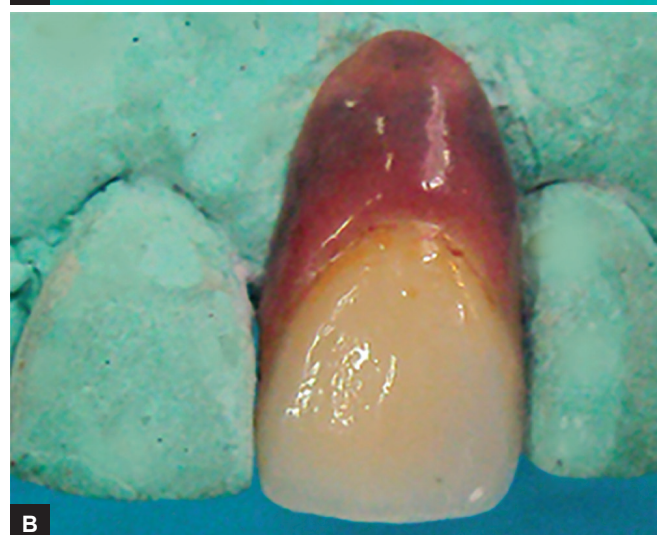
Figs 3A and B: (A) Metal tryin, and (B) characterization using gingival porcelain

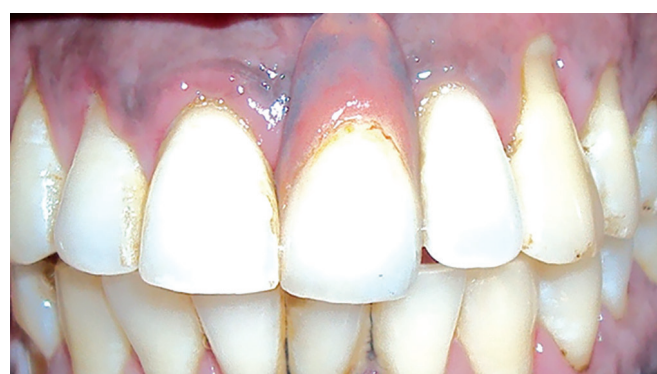
Fig. 4: Final restoration
