CASE REPORT

Functional Rehabilitation of Mandibular Molar with Separated Instrument and External Root Resorption

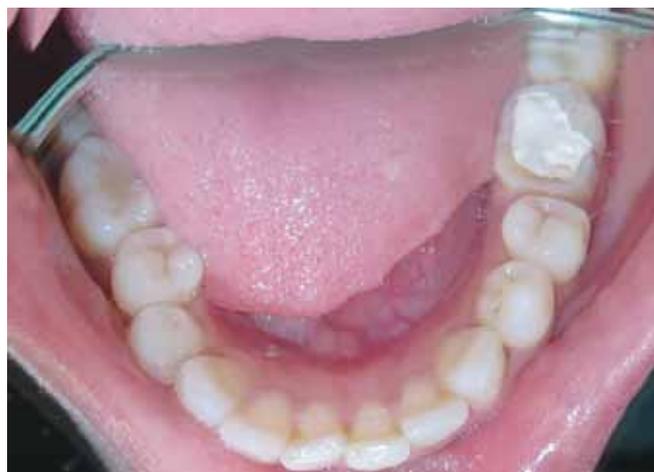
dentistry and endodontics with complain of pain in lower left posterior region of the mouth since 1 to 2 months. Pain was dull, intermittent and of short duration which aggravated on cold stimulation. Patient gave history of root canal treatment of #36 (FDI numbering system) 8 months back. On examination, tooth #36 was very sensitive to vertical and horizontal percussion. Affected lower left posterior region had normal periodontal support (Figs 1 and 2).

Fig. 1: Preoperative view showed temporary restoration in #36

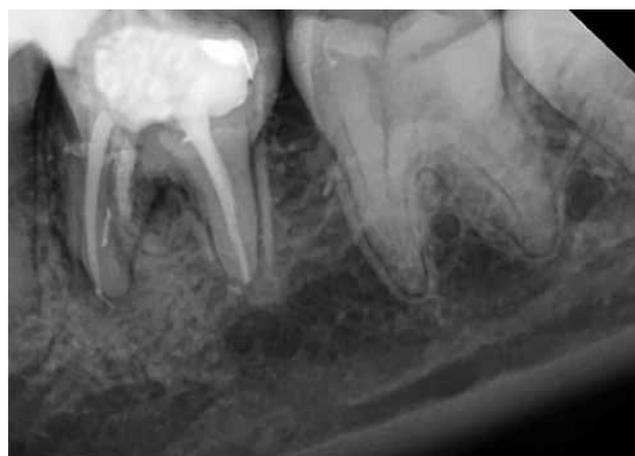
Intraoral periapical radiograph of the involved tooth #36 showed deficient obturation and possibly separated instrument at the middle-apical third of mesial root of #36 about 3 to 4 mm in length. Periapical radiolucency about 2 to 3 mm in diameter was observed around mesial root. There was root as well as bone resorption evident on radiograph in apical portion of mesial root. Cone beam

Fig. 2: Intraoral periapical radiograph of #36

computed tomography (CBCT) confirmed the presence of separated instrument in mesiolingual canal at 3 to 4 mm short of the apex of #36.

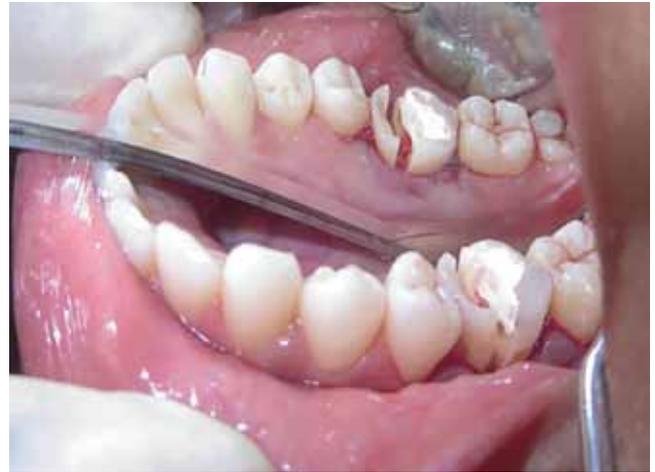
Fig. 4: Separated mesial and distal halves of #36

Inferior alveolar nerve block anesthesia (2% lignocaine with epinephrine in 1:80000) was administered and full thickness periodontal flap was raised with crevicular incision from first premolar (#34) to second molar (#37). Buccal and lingual periodontal flaps were reflected. A long shank tapered fissure carbide bur (169L) was used to make vertical cut towards the furcation area to bisect mesial and distal halves of #36. A fine probe was passed through the cut to ensure separation⁴⁻⁸ (Figs 3 to 5).

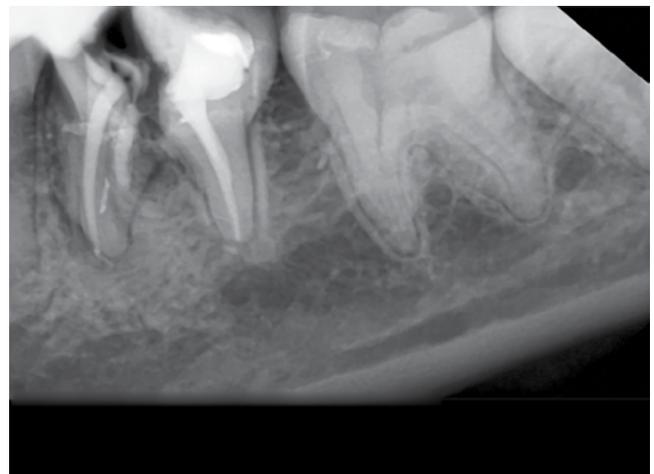
Fig. 5: Intraoral periapical radiograph showing separated mesial and distal halves of #36

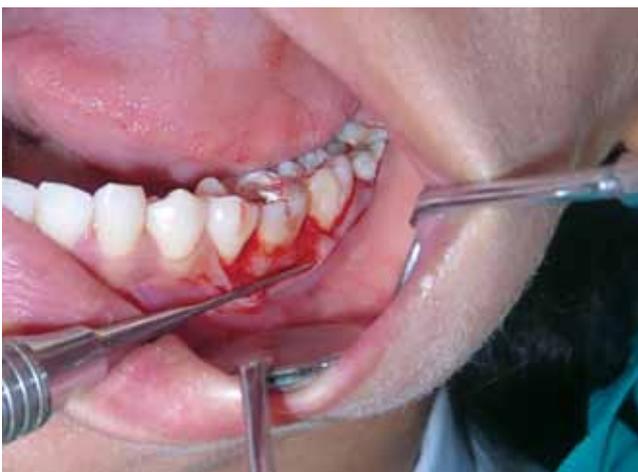
Fig. 3: Full thickness periodontal flap raised

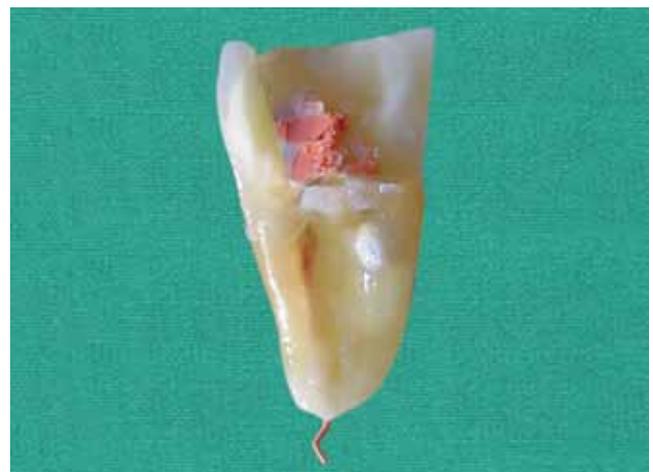
Fig. 6: Extracted mesial half of #36 with apical resorption

The mesial half of #36 was extracted and remaining distal half was smoothed. The surgical field area was

flushed with saline and chlorhexidine (0.02%) to ensure no residual debris (Figs 6 and 7). Mesial root socket was filled with bone graft (demineralized freeze dried bone allograft DFDBA) and suturing (black braided silk suture 3-0) was done followed by Coe-Pak application. Patient was recalled for check-up after 24 hours. Periodontal pack and sutures were removed after 10 days.

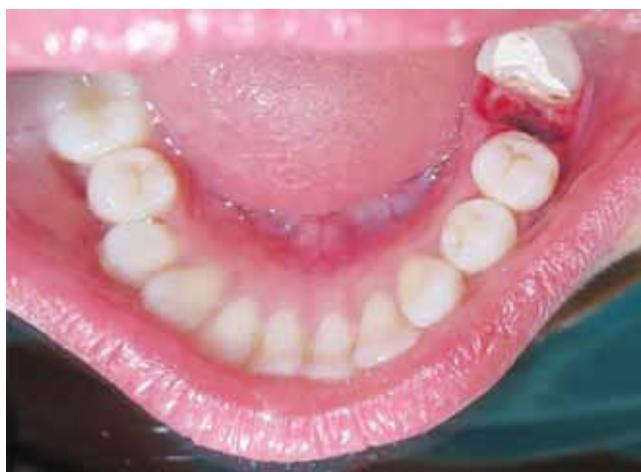
Fig. 7: Intraoral view showing extraction socket of mesial half of #36

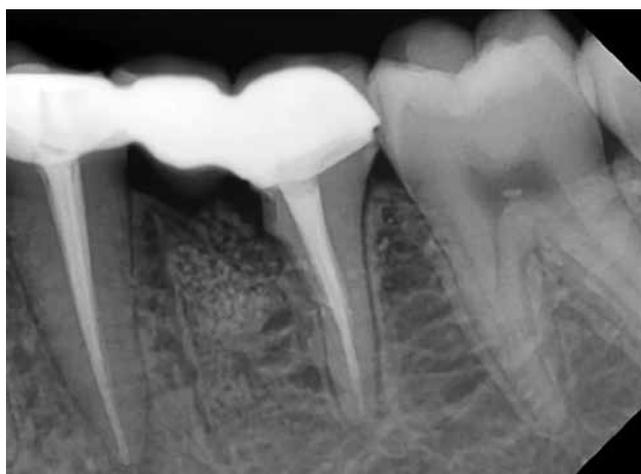
Fig. 8: Prosthetic rehabilitation of #35 and #36

For the prosthetic rehabilitation, temporary partial prosthesis was placed in #35 and #36 and kept under observation for 2 months. Later on, patient reported with severe sensitivity to hot and cold beverages in relation to #35. So, endodontic therapy was done with #35, and fixed partial denture was made with #35 and #36 (Fig. 8).
